**Flood Control Project Maintenance  
Levee Inspections**

## Maintenance Issue Types Only, Levee Inspection Report By Mile - Spring 2018

### Reclamation District No. 1600 Mull

Waterway	Bank	Unit Miles	Inspection Start/End	Inspector
Unit No. 01 Sacramento River	Right	10.46	04/10/2018 05/08/2018	Zach Jojola

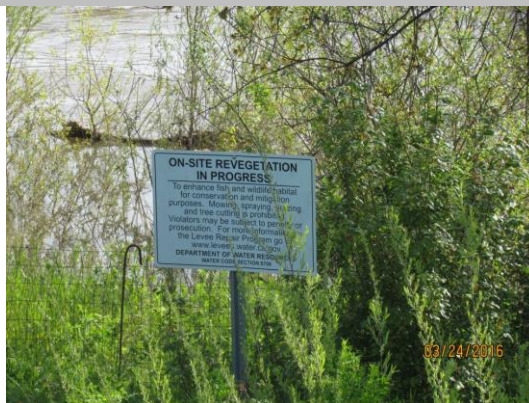
Photo 2 of 2 : SP\_2018\_RD1600\_191\_22\_20180306\_00022.jpg

LM Start	1.01	Rating **	A/W	Issue No.	22 (cont)	
LM End	1.10	Issue Type +	Ma	Location *	WS	
Category	Earthen Levee			GPS Latitude/Longitude		
				Start		End
Item	Vegetation			38.689092 °		38.690368 °
				-121.635616 °		-121.635669 °
DWR ID	DWR_RD1600_01_f_2017_22					
Comment Code						
V8 : Environmental Requirements.						
Inspector Comment

Sign stating revegetation site. Spring 2016.

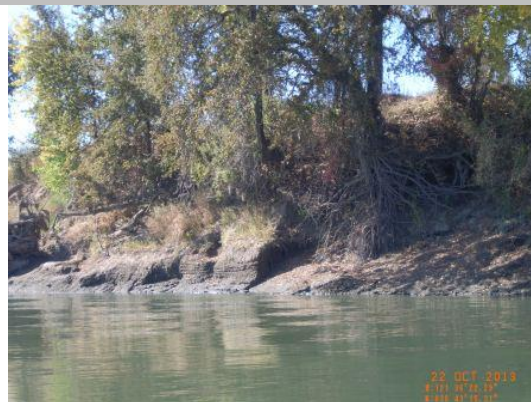
Photo 1 of 1 : SP\_2018\_RD1600\_191\_3\_20180306\_00003.jpg

LM Start	3.58	Rating **	M	Issue No.	3
LM End	3.83	Issue Type +	Ma	Location *	WS
Category	Supplemental			GPS Latitude/Longitude	
				Start	End
Item	2015 USACE Erosion Survey, DRAFT			38.717770 °	38.721351 °
				-121.607423 °	-121.606414 °
DWR ID	DWR_RD1600_01_s_2016_3				
Comment Code					
Inspector Comment					
1997 - Steep high bank. 2005 - Some small pockets in the low toe near the waterline. 2006 - Minor slope clearing. 2010 - Minor new erosion. 2011 - Multiple trees have fallen since last year. Some other trees look ready to fall. Significant new erosion since last year. 2012 - Minor new erosion. 2013 - Minor new erosion. 2015: New minor erosion at toe. [2015 Site ID: SAC 74-4 R]

USACE 2013 Photo #1

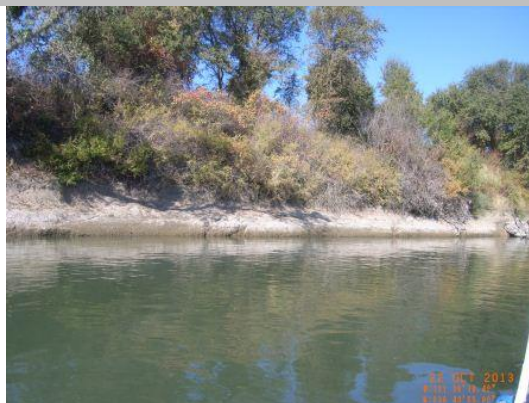
Photo 1 of 1 : SP\_2018\_RD1600\_191\_8\_20180306\_00010.jpg

LM Start	4.34	Rating **	M	Issue No.	8
LM End	4.86	Issue Type +	Ma	Location *	WS
Category	Supplemental			GPS Latitude/Longitude	
				Start	End
Item	2015 USACE Erosion Survey, DRAFT			38.728684 °	38.736110 °
				-121.605844 °	-121.604153 °
DWR ID	DWR_RD1600_01_s_2016_8				
Comment Code					
Inspector Comment					
1997 - Very steep bank. 2005 - Lots of small trees down along the bank at the upstream end. 2006 - Minor new erosion, but slow. 2010 - Almost all of the roots are exposed on the trees, appears ready to fall. 2011 - New erosion and tree popouts. 2012 - Site has become overgrown with vegetation, making it hard to observe. 2015: Dense vegetation made observation difficult. [2015 Site ID: SAC_75-3_R]

USACE 2013 Photo #1

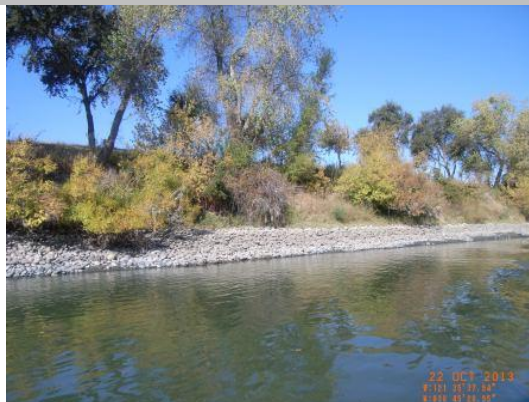
Photo 1 of 1 : SP\_2018\_RD1600\_191\_9\_20180306\_00011.jpg

LM Start	6.30	Rating **	A/W	Issue No.	9
LM End	6.36	Issue Type +	Ma	Location *	WS
Category	Supplemental			GPS Latitude/Longitude	
				Start	End
Item	2015 USACE Erosion Survey, DRAFT			38.755246 °	38.756186 °
				-121.594206 °	-121.594024 °
DWR ID	DWR_RD1600_01_s_2016_9				
Comment Code					
Inspector Comment					
2011 - Large vertical eroded face from a rotational failure just below pump. 2015: Does not meet criterial. [2015 Site ID: SAC_77-0_R]

USACE 2013 Photo #1

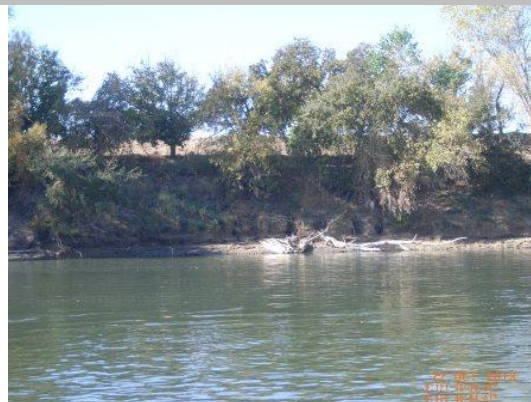
Photo 1 of 1 : SP\_2018\_RD1600\_191\_6\_20180306\_00008.jpg

LM Start	6.95	Rating **	M	Issue No.	6
LM End	6.98	Issue Type +	Ma	Location *	WS
Category	Supplemental			GPS Latitude/Longitude	
				Start	End
Item	2015 USACE Erosion Survey, DRAFT			38.764801 °	38.765219 °
				-121.594926 °	-121.595049 °
DWR ID	DWR_RD1600_01_s_2016_6				
Comment Code					
Inspector Comment					
2006 - Eddy scour off end of rock causing erosion and scour hole near levee. Sandy silt bank with rock on upstream end. 2010 - Trees are leaning more, minor new erosion. 2011 - Many of the tree roots have scoured out and trees look ready to fall. 2015: No observed changes. [2015 Site ID: SAC 77-7 R]

USACE 2013 Photo #1

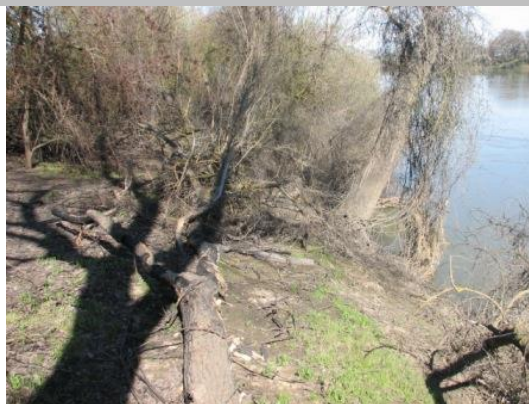
Photo 1 of 5 : SP\_2018\_RD1600\_191\_20\_20180306\_00013.jpg

LM Start	7.10	Rating **	A/W	Issue No.	20
LM End	7.10	Issue Type +	Ma	Location *	WS
Category	Earthen Levee			GPS Latitude/Longitude	
				Start	End
Item	Erosion / Bank Caving			38.766691 °	38.766691 °
				-121.596300 °	-121.596300 °
DWR ID	DWR_RD1600_01_s_2012_20				
Comment Code					
E1 : Note and monitor erosion site.					
Inspector Comment					
Erosion present at the berm, and it hasn't got into the levee prism yet.

This another view of the site.

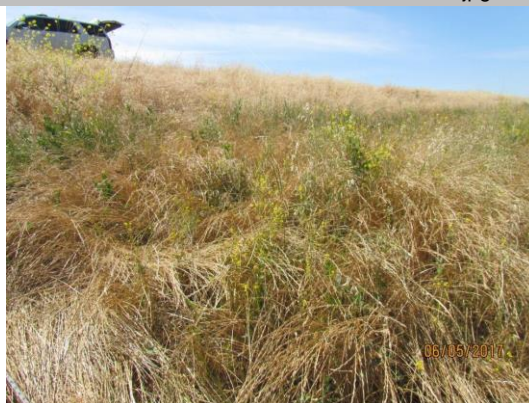
Photo 1 of 3 : LEVAL\_SP\_2018\_202\_1210.jpg

LM Start	0.20	Rating **	A/W	Issue No.	17	
LM End	4.21	Issue Type +	Ma	Location *		
Category	Supplemental			GPS Latitude/Longitude		
				Start	End	
Item	2017 Storm Damage			38.733333 °	38.676750 °	
				-121.633611 °	-121.643250 °	
DWR ID	DWR_RD1600_02_f_2017_17					
Comment Code						
Inspector Comment						
Levee Evaluation Comments						
Description:						
Site ID No:202						
Site Designation:RD 1600-01						
Repair Type: Erosion						
Rating:Area of Concern						
Field Date:6/5/2017						
Notes: dense vegetation makes identification difficult

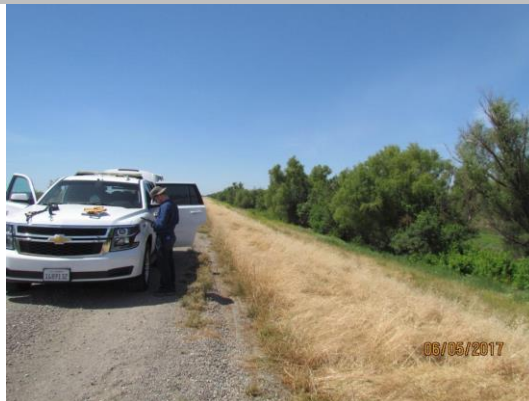
Photo 3 of 3 : LEVAL\_SP\_2018\_202\_371.jpg

LM Start	0.20	Rating **	A/W	Issue No.	17 (cont)	
LM End	4.21	Issue Type +	Ma	Location *		
Category	Supplemental			GPS Latitude/Longitude		
				Start		End
Item	2017 Storm Damage			38.733333	°	38.676750
				-121.633611	°	-121.643250
DWR ID	DWR_RD1600_02_f_2017_17					
Comment Code						
Inspector Comment						
Levee Evaluation Comments						
Description:						
Site ID No:202						
Site Designation:RD 1600-01						
Repair Type: Erosion						
Rating:Area of Concern						
Field Date:6/5/2017						
Notes: dense vegetation makes identification difficult

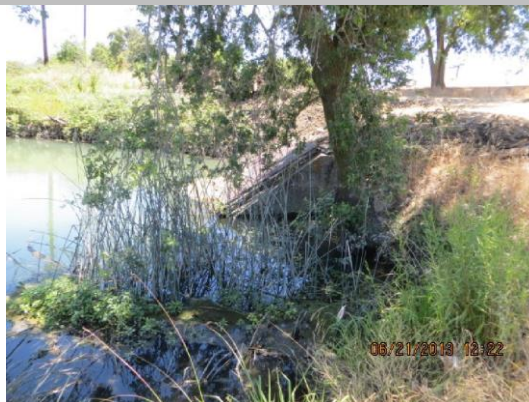
Photo 1 of 3 : UCIP\_SP\_2018\_15303\_25158.jpg

LM Start	4.17	Rating **	A/W	Issue No.	302
LM End	4.17	Issue Type +	Ma	Location *	
Category	Supplemental			GPS Latitude/Longitude	
				Start	End
Item	DWR UCIP LMA Responsibility			38.677286 °	38.677286 °
				-121.643683 °	-121.643683 °
DWR ID					
Comment Code					
Inspector Comment					
FS_ID:15303 DS_ID:21502 EP_NO: N/A Repair Type: No Action Needed Crossing Status: Found UCIP Comments: FIELD_STRUCT_DESC: 72-inch by 72-inch reinforced concrete box drainage culvert through the levee, 26 feet below the crown. Slide gate on the waterside (WS) slope in a 9-foot by 10-foot concrete box. Culvert passes under the bypass canal, the railroad, and County Road 22 and terminates in the canal on the southwest side of the County Road 22 bridge. [Additional Reference(s): DWR Levee Log, 1988. USACE Sacramento O&M Manual 123, August 1955, (Station 155+00)]. FS Date: 6/21/2013

Concrete intake structure on LS.

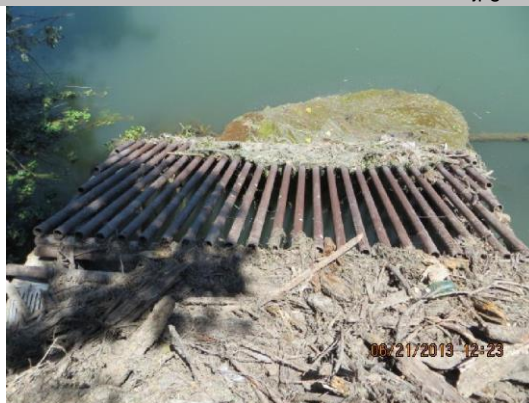
Photo 2 of 3 : UCIP\_SP\_2018\_15303\_25157.jpg

Concrete intake structure on LS.

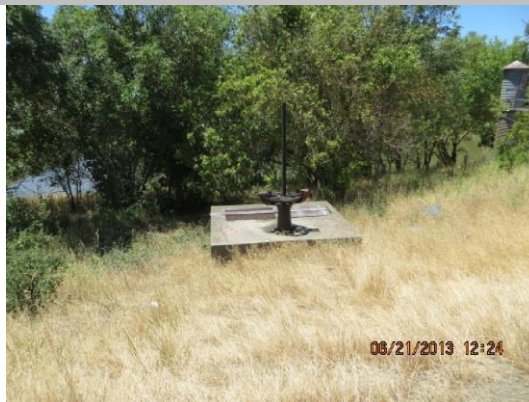
Photo 3 of 3 : UCIP\_SP\_2018\_15303\_25156.jpg

Slide gate in 9'X10' concrete box on WS slope.
